## CASE STUDY

# 'DIGITAL TWIN' MODELING, SIMULATION, ANALYSIS & TROUBLESHOOTING

Numerous uncontrolled load-lowering incidents had been experienced on the auxiliary winch of the FPSO port crane.

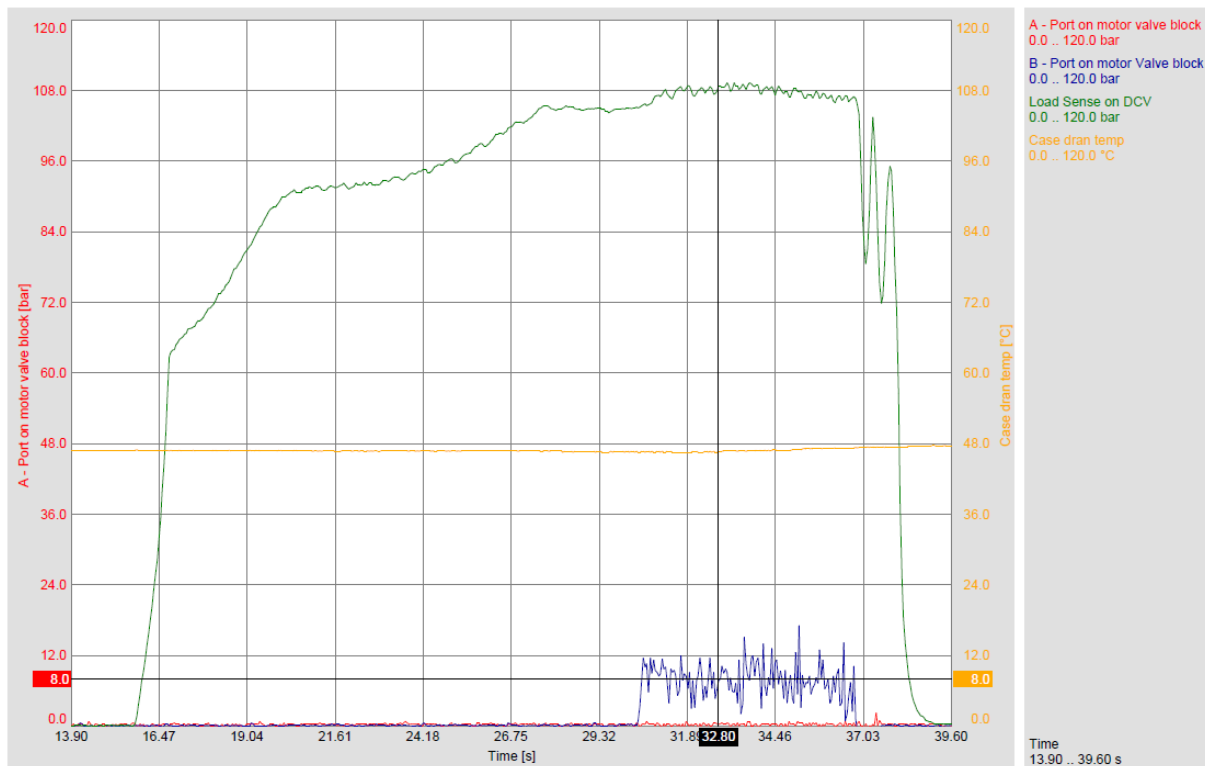
Figure 4: Port Crane - 8 bar pilot pressure to lower 6.6t load

During testing it was found that the pilot pressure to open the CB valve ranged from 8 – 21 bar (see Figures 4 and 5) on the port and starboard crane auxiliary winches with loads between 53 – 88 % of SWL.

From both the actual measured and calculated pilot pressures, it is evident that the CB valve opens before the static brake is fully released.

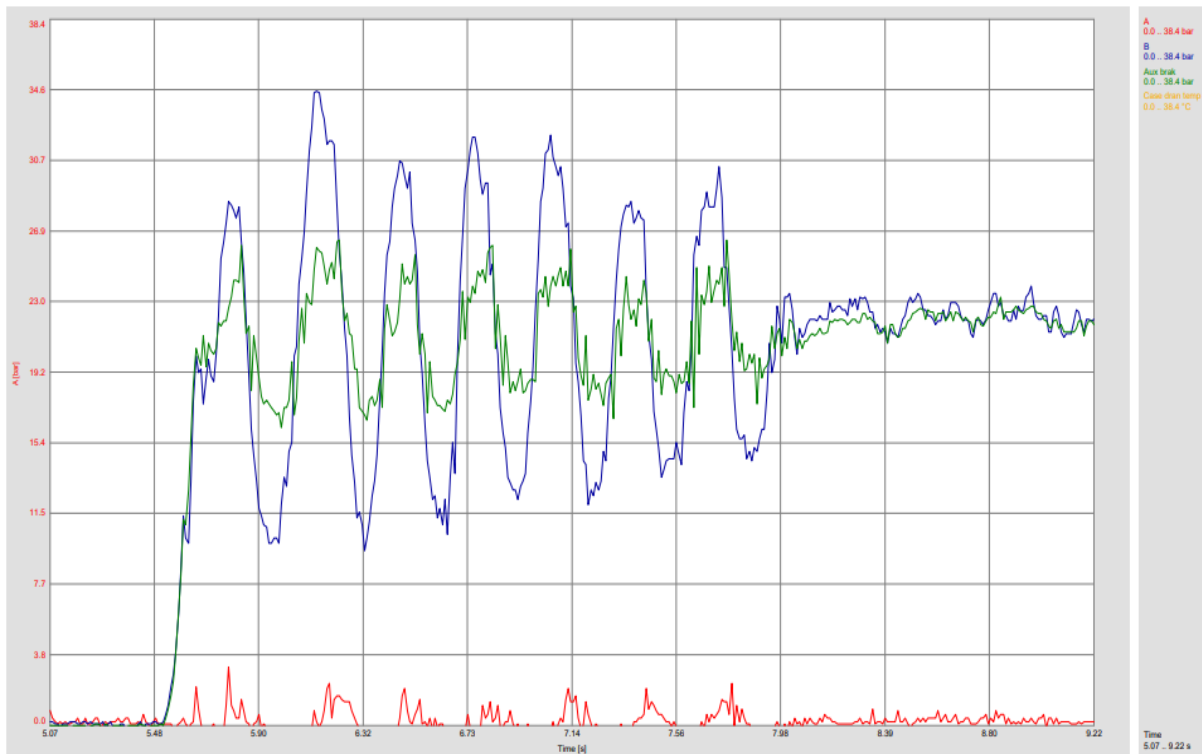
**Figure 6:** Evidence of the brakes not fully releasing before the CB valve can open.

The CB valve opening before the static brake is fully released causes the pressure in the auxiliary winch hydraulic circuit to fluctuate resulting in the static brakes being applied and released rapidly. This causes the hydraulic motor to rotate in a stop-start manner repeatedly which damages the motor and static brake and creates heat in the system.

During testing it was found that the starboard crane with a 4t load (54% SWL) is currently experiencing this phenomenon. Figure 6 below shows the CB valve (blue line) opening before the static brake (green line) has opened and depicts the resultant cyclic application of the static brake due to pressure fluctuations in the auxiliary hoisting system.

The cyclic application of the static brake was also physically heard by the Pressure Dynamics Lead Crane Technician during this test.

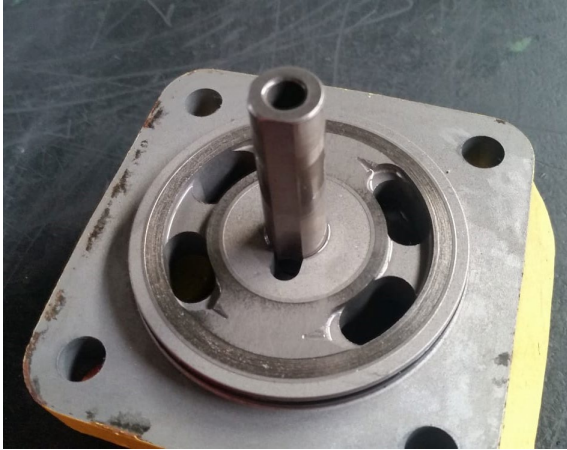
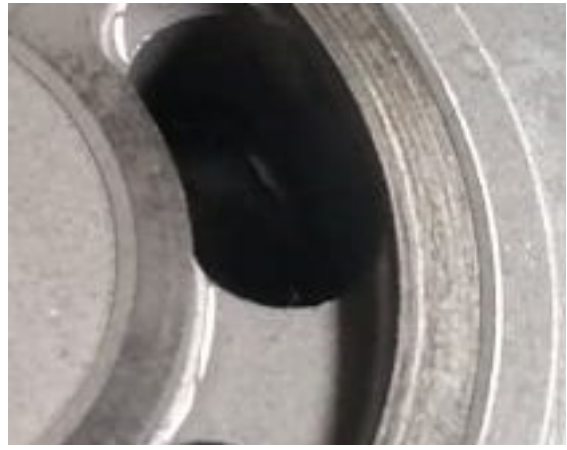
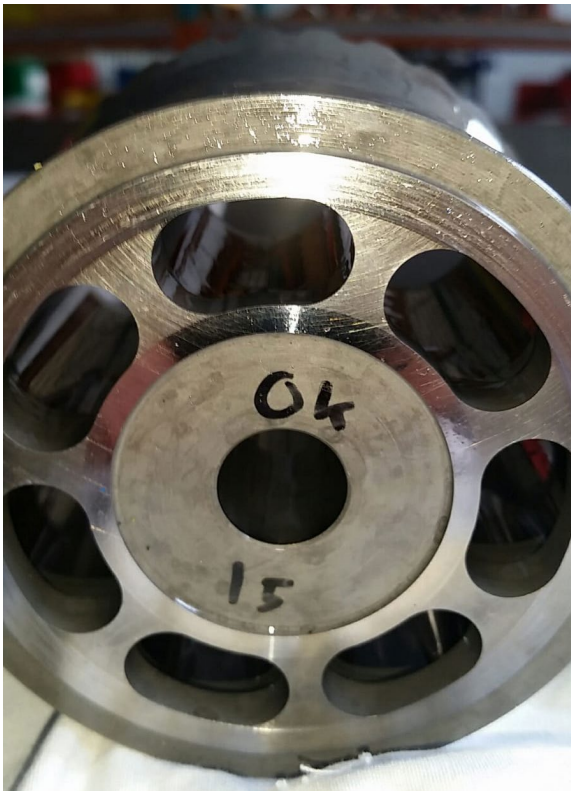
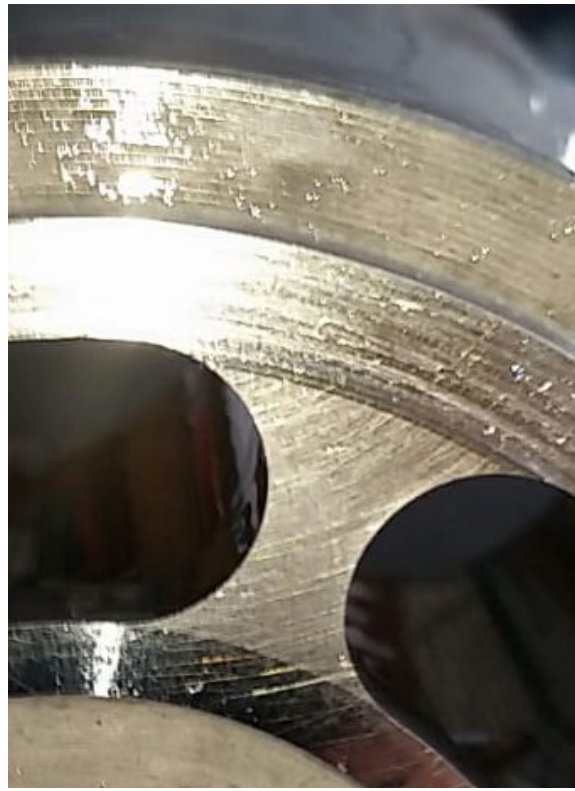
There was significant scoring evident on the port plate and cylinder barrel face and evidence of cavitation. The cavitation is a result of the scoring on the mechanical faces, creating peaks and troughs in the metal, allowing hydraulic fluid to leak out into the case of the motor.

**Table 1:** Scoring on port plate and cylinder barrel – port crane auxiliary winch motor removed June 2019

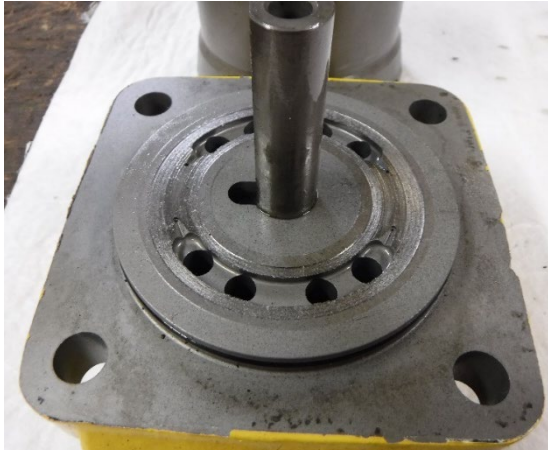
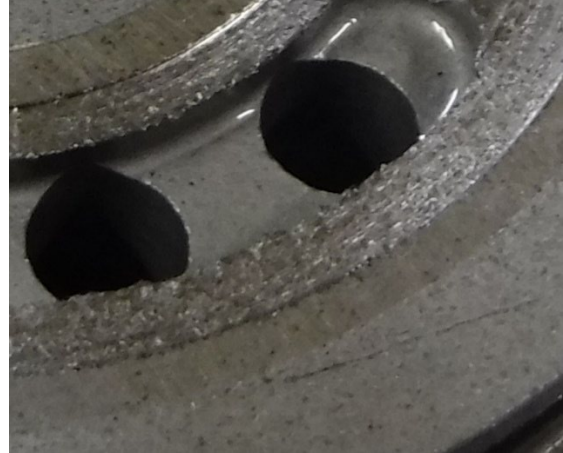
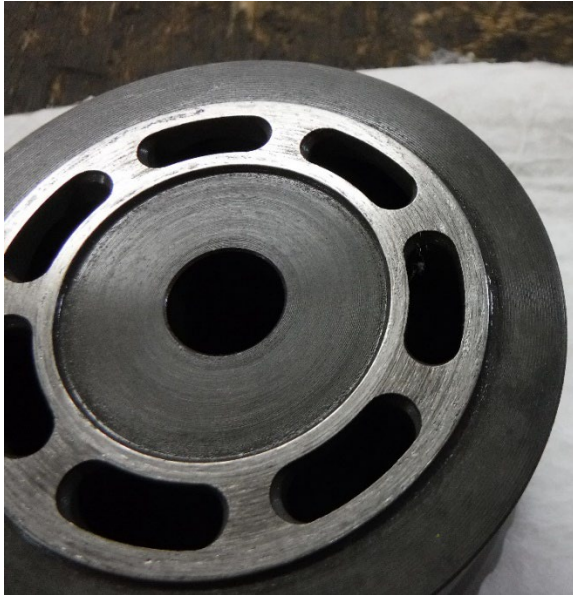
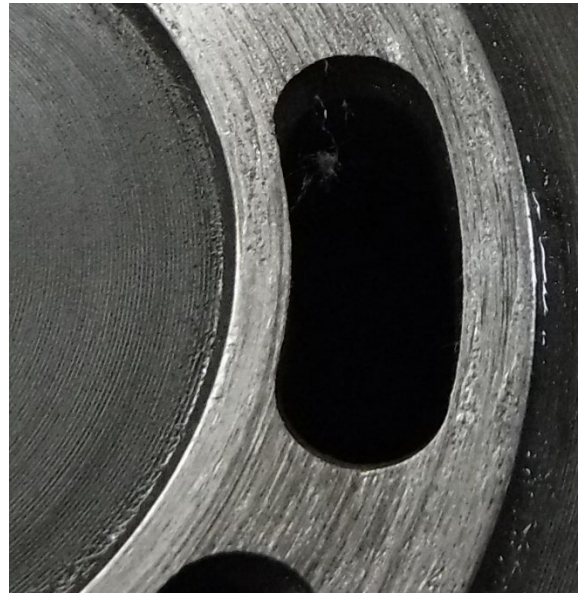
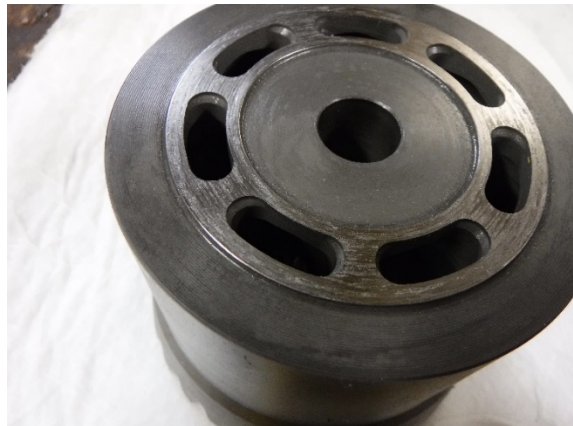
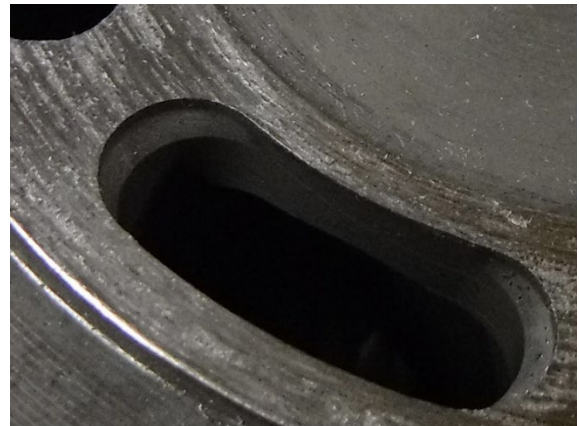
**Table 2:** Scoring on port plate and cylinder barrel – port crane auxiliary winch motor removed April 2019

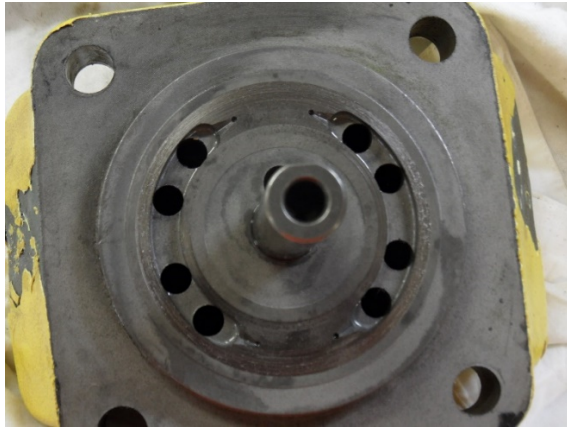
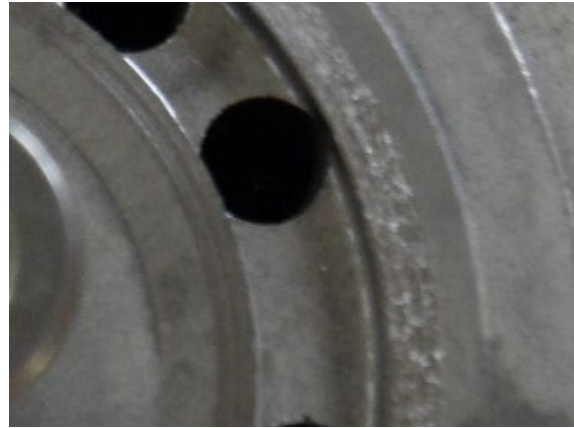
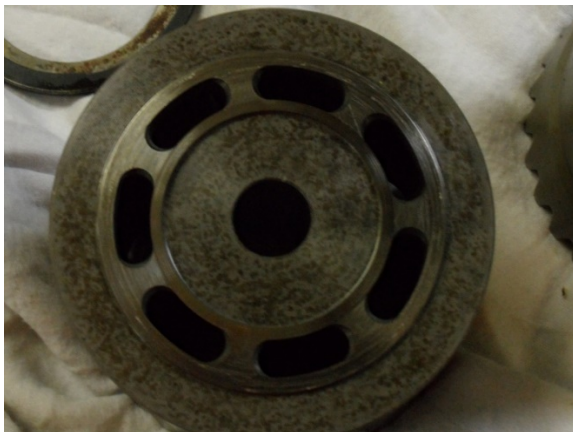
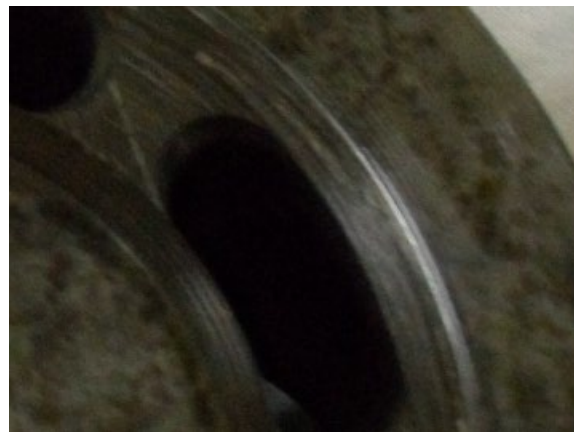
**Table 3:** Scoring of port plate and cylinder barrel – starboard crane main winch motor removed June 2019

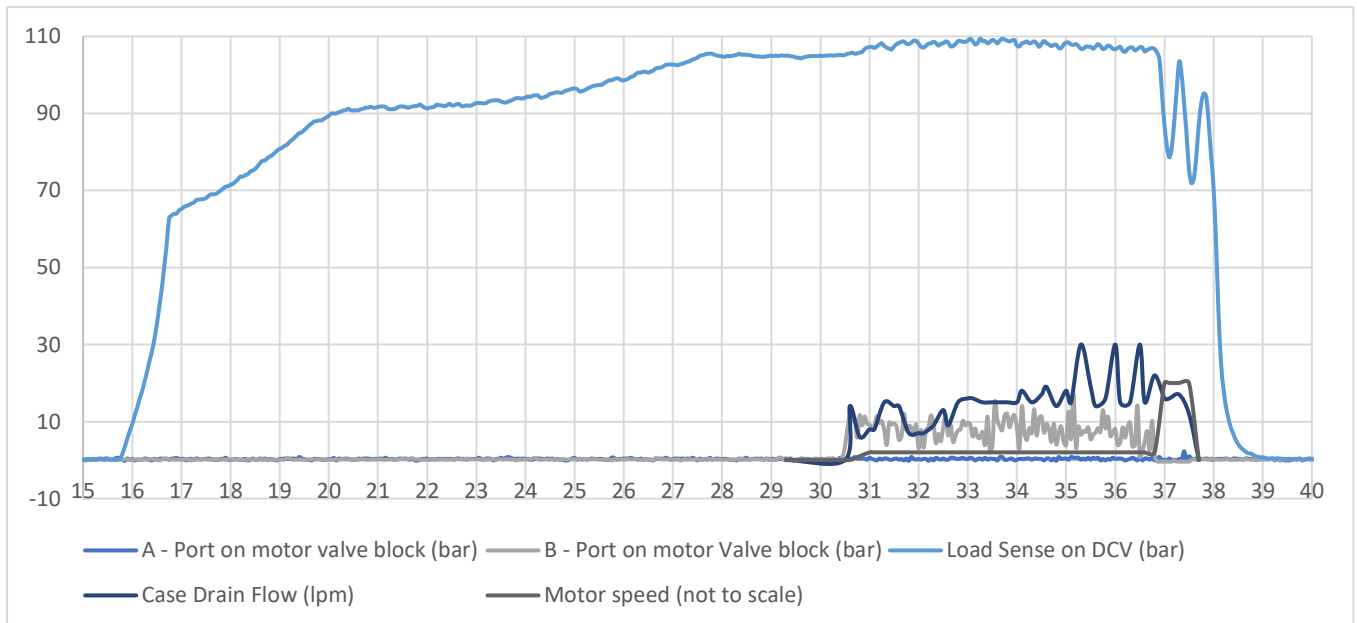
**Figure 7:** Port crane auxiliary motor during simulation with 88% SWL

This high case drain flow is depicted in Figure 7 where the uncontrolled load lowering incident was simulated with a load of 6.6t (88% SWL).

in the down direction whilst luffing up, the case drain flow (dark blue line) spiked to between 15 – 30 L/min.

This is evident in Figure 7 where the motor speed increases significantly at the 37 second mark indicating that the motor is free-spinning, and the load is lowering uncontrollably.

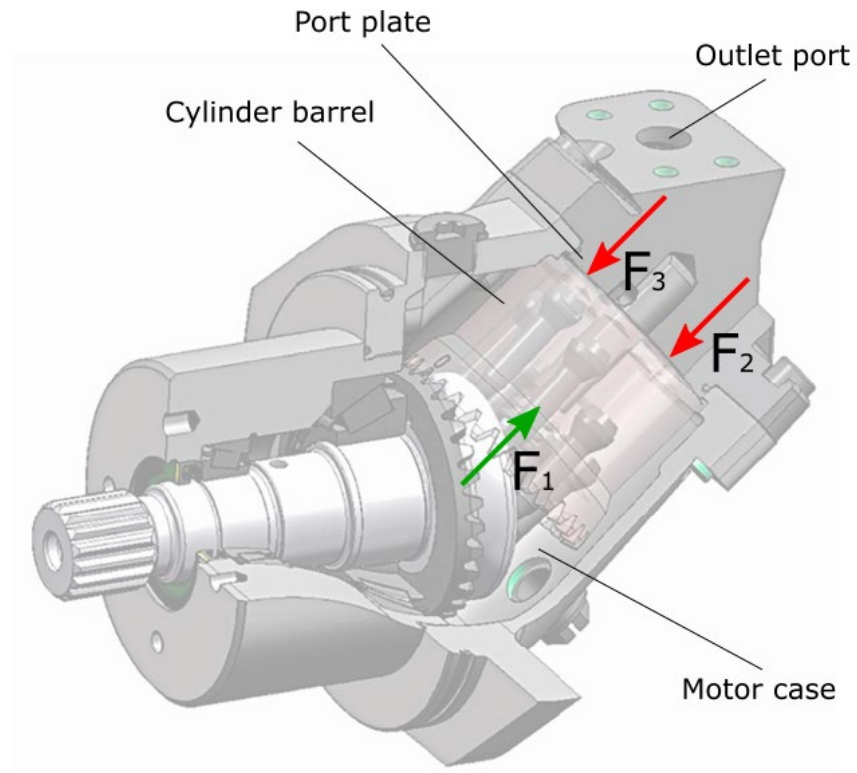
**Figure 8:** Motor cylinder barrel forces during operation

If this back pressure is high enough then it can lift the cylinder barrel off from the port plate and allow the motor to free spin which results in the uncontrolled load lowering incidents.

During normal operation in a healthy motor, the spring pressure ( $F_1$ ) is greater than the pressures acting on the cylinder barrel ( $F_2$  &  $F_3$ ); thus, the cylinder barrel and port plate are constantly in contact.

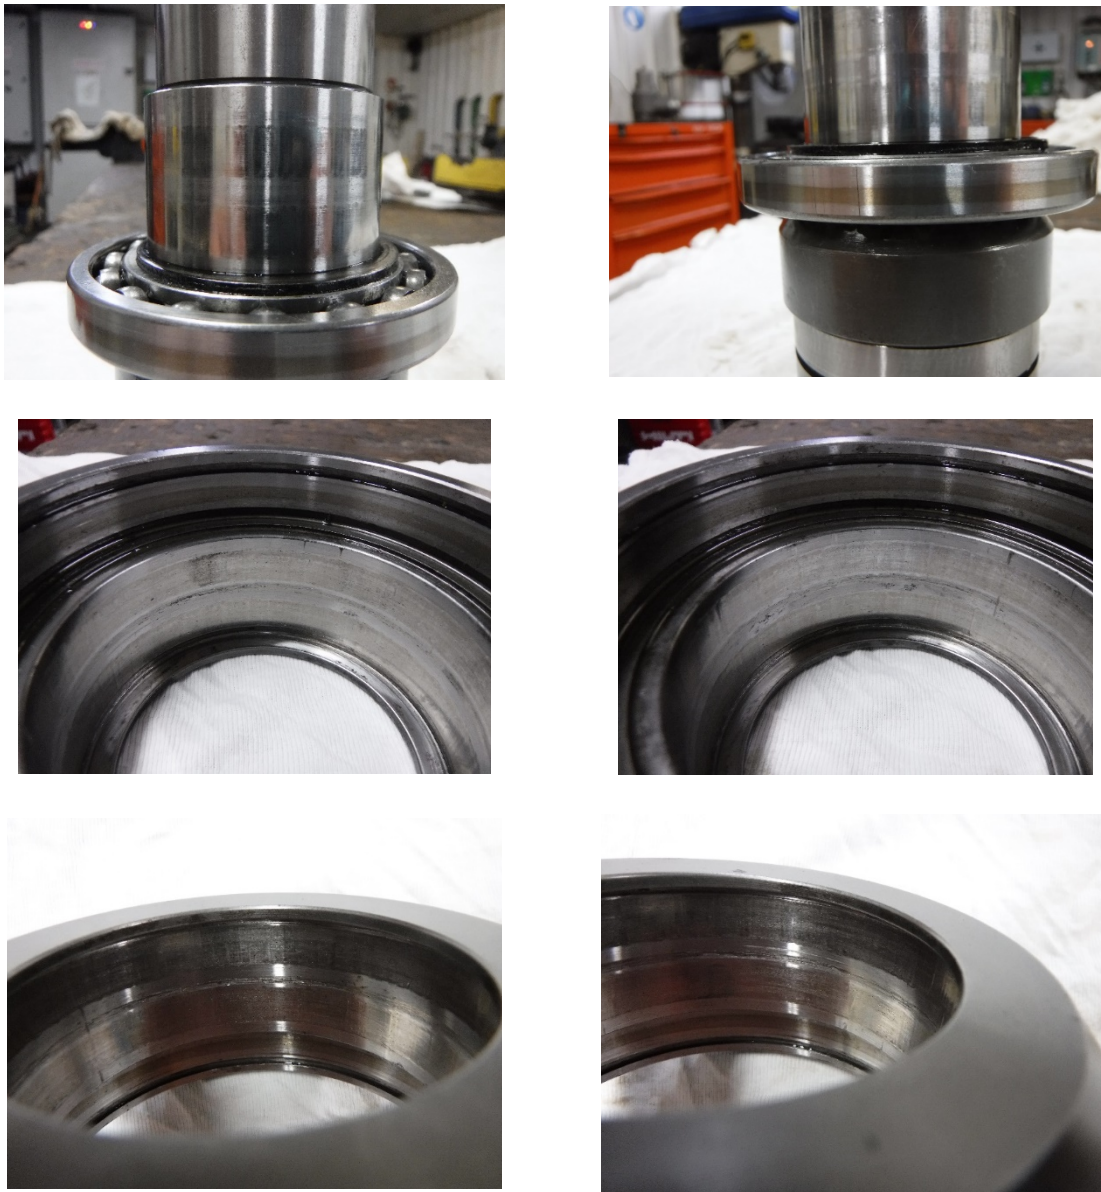
**Table 4:** Brake pack damage

Following componentry inspection, it was found that there was significant scoring on the motor to gearbox shaft where the sprag clutch is fitted and the shaft bearings also exhibited signs of heat damage.

Similarly, the disc carrier gear had deep scoring where the sprag clutch cams contact and the cams themselves were also damaged and it was recommended to replace the entire brake pack.
