## CASE STUDY

# BALANCE MACHINERY LUFFING CYLINDERS REFURBISHMENT

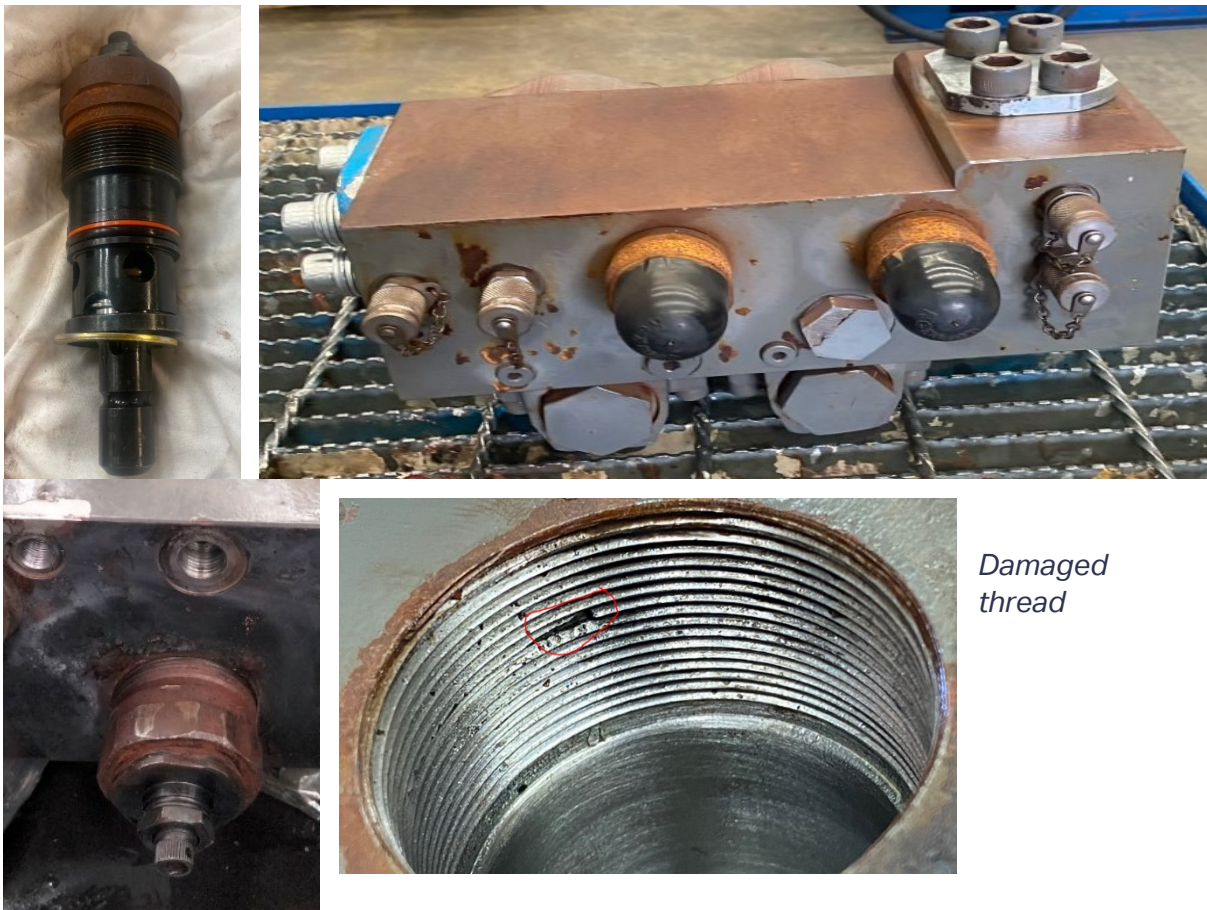
However, upon further inspection, the Low-Pressure Relief valve was found to have been damaged during the last strip and rebuild within the threads. The High-Pressure Relief valve ceased into the port and could not be removed. Pressure relief valve body also has signs of surface rust present.

*Seized HP Relief valve thread*

ports. With importance of the ceased High-pressure valve, the repairs required to bring back the manifold to OEM specifications this would introduce additional leak paths in the future. Given criticality of equipment, the Manifold and all other components were recommended to be replaced with new hydraulic assembly.

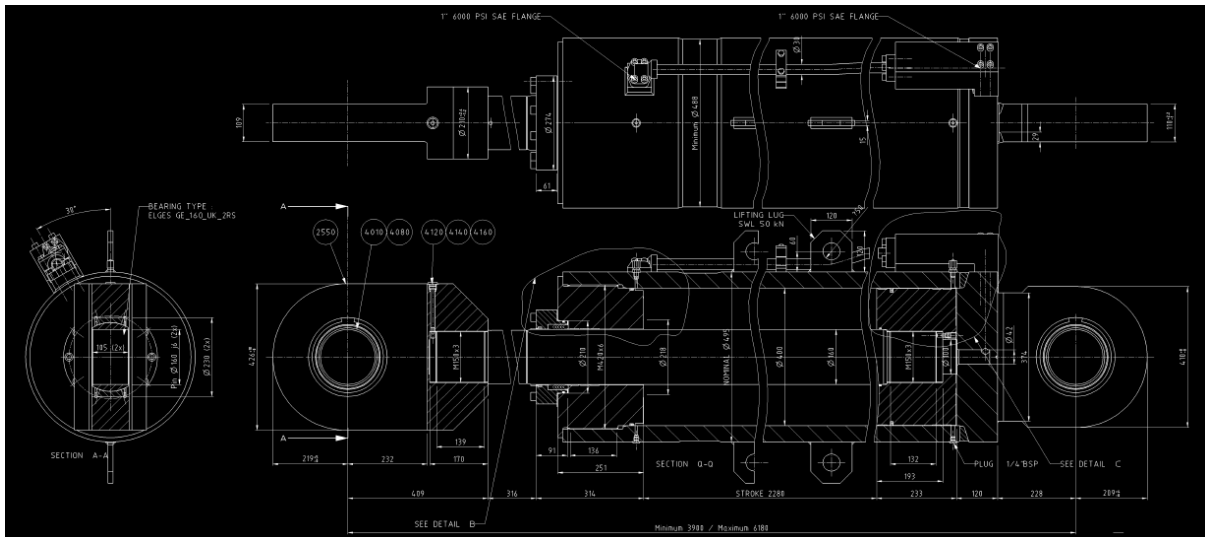
*Drawing of the Hydraulic Boom Luffing Cylinder*

During the final assembly process of mating the newly supplied Manifold to the existing luffing Cylinder, it was found that the bolt holes in the Cylinder were larger than the original OEM design indicating a previous unknown modification had been performed unrecorded.

The result was an agreed modified bolting arrangement by the client to the newly supplied Manifold and implemented into the final assembly prior to performing the third and final Assembly Testing.
