CASE STUDY

LUFFING WIRE DROPPED ROPE RECOVERY & ROPE CHANGEOUT

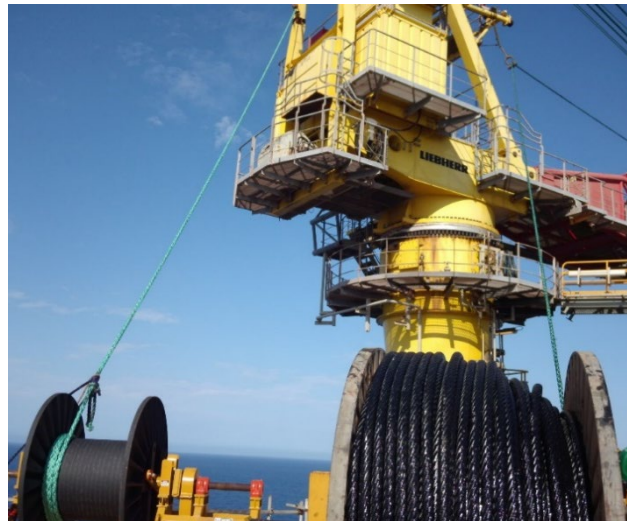
The old luffing wire rope was cut above the dropped section lying on the HV cable trays and walkway and terminated onto the empty drum on the spooling winch. A soft line was connected to the other end of the old luffing wire rope prior to retrieving it which left the soft line reeved and ready for the new luffing wire rope installation.

With the wire ropes retrieved from the crane, the team then focused on disposing the dropped section of old luffing wire rope. Approximately 200m of wire rope was cut up using a wire rope cutter and slung together ready for disposal. The walkway area was then washed down to clean off any wire rope grease and the area reopened for access.

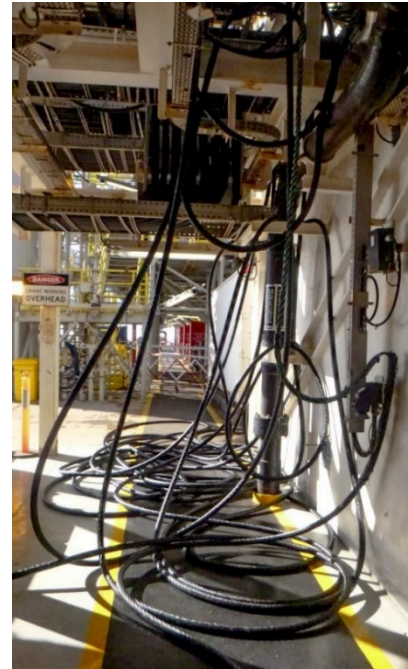
The new wire rope was received at Pressure Dynamics' Karratha facility and a close visual inspection was conducted on the entire length of rope. No areas of concern or discard criteria were identified.

The rope was then lubricated and spooled onto a suitable steel drum prior to being mobilized again to the offshore facility.

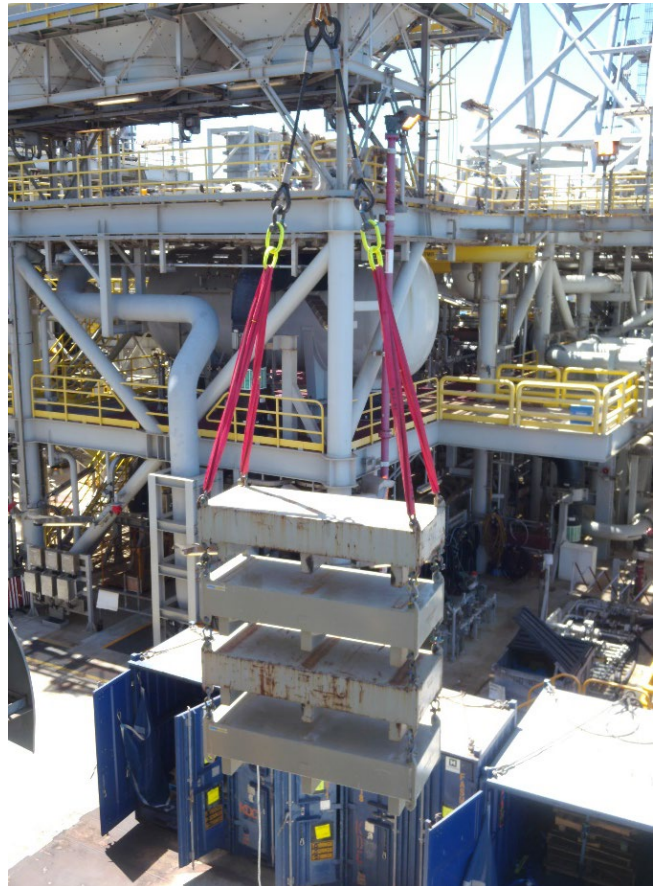
Upon client request, the slew bearing rocking motion test was conducted with a load of 38t on the main hook.

Performing the rocking motion test in this manner is not common testing practice – Pressure Dynamics provided technical advisory from its onshore engineering team to ensure all was conducted safely. The test was conducted in the same manner as when the crane was commissioned to ensure consistent and comparative results against the original commissioning paperwork and OEM procedure.
