## CASE STUDY

# MARINE LOADING ARMS HYDRAULIC TUBING UPGRADE AND REPLACEMENT

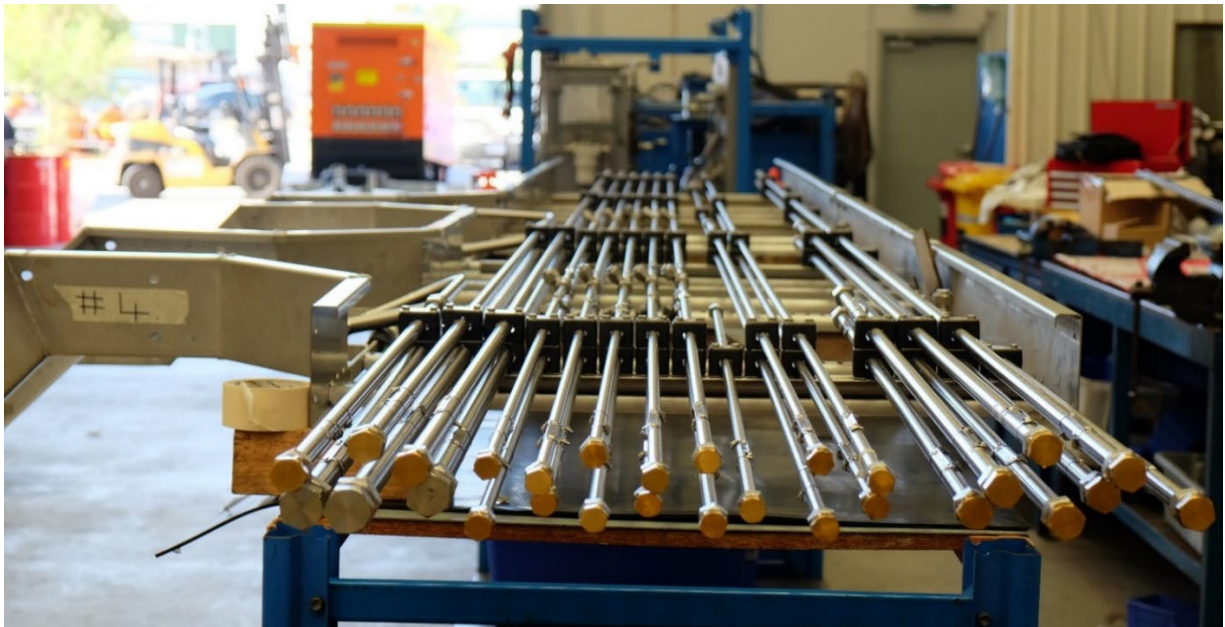
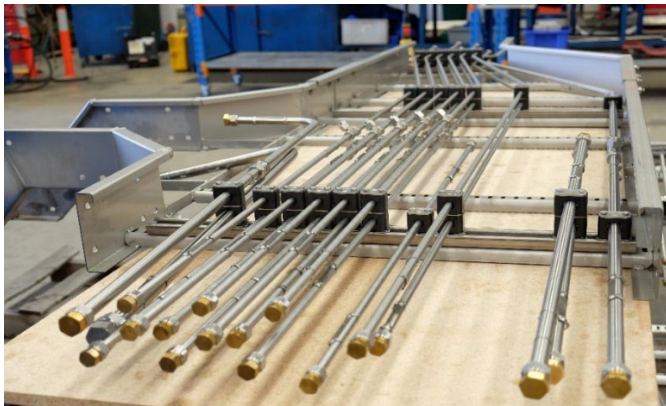
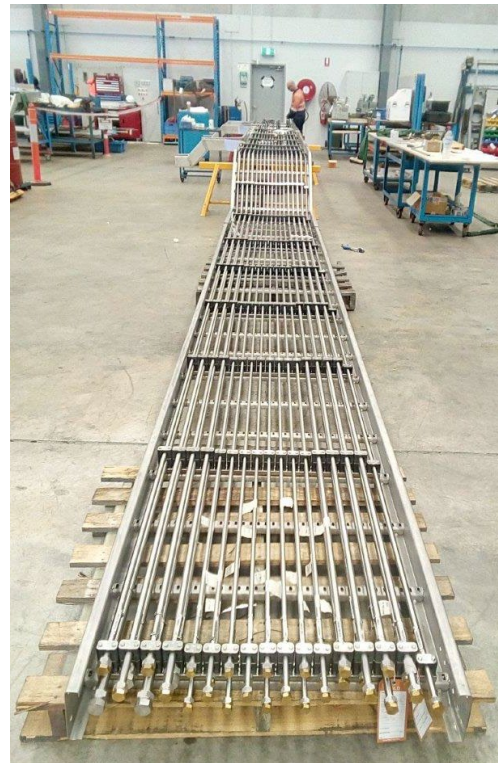
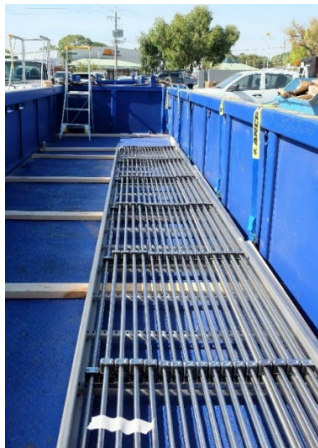
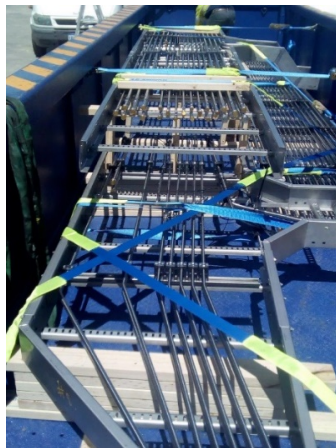
Then were preserved and packed for mobilisation to site.

The modules were progressively installed and interconnected at site.

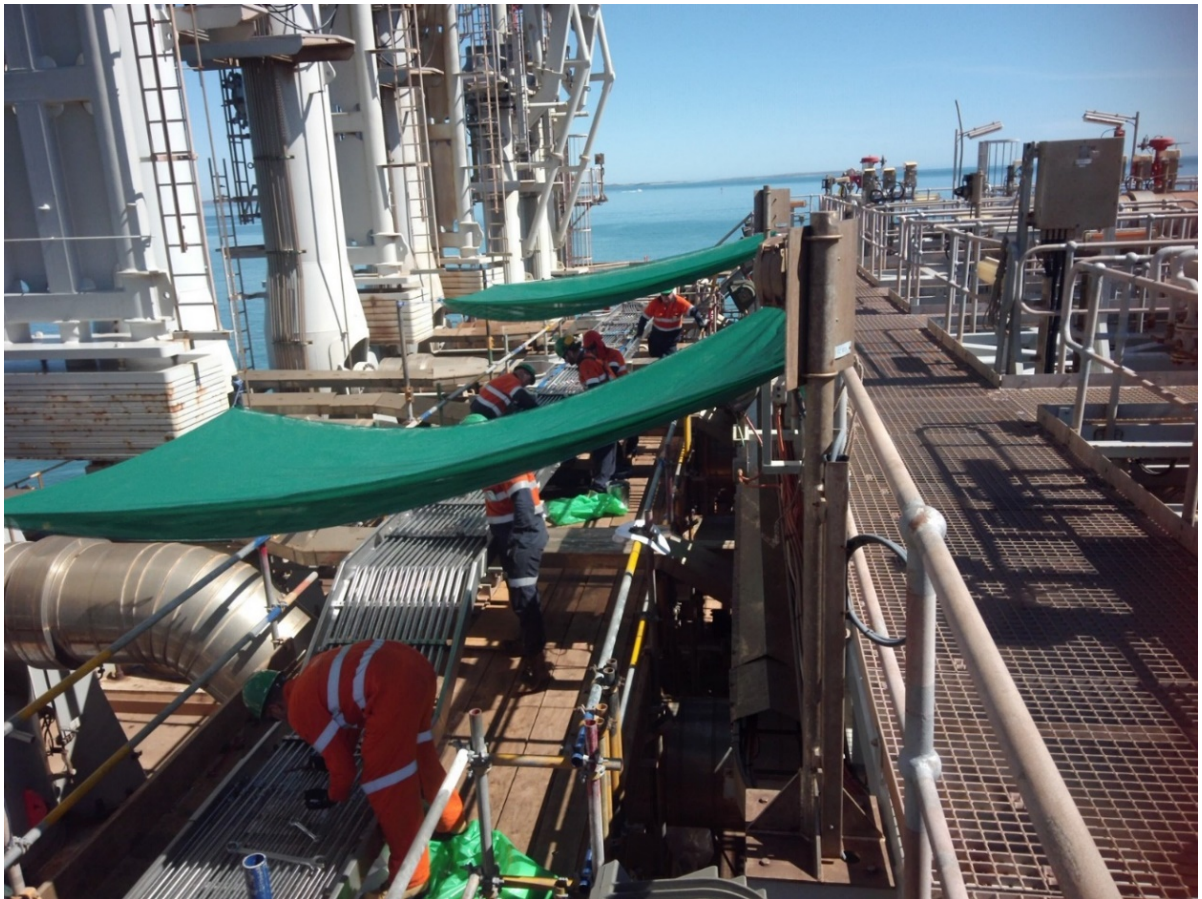
Complex, interconnecting tubing installation was installed and completed at site.

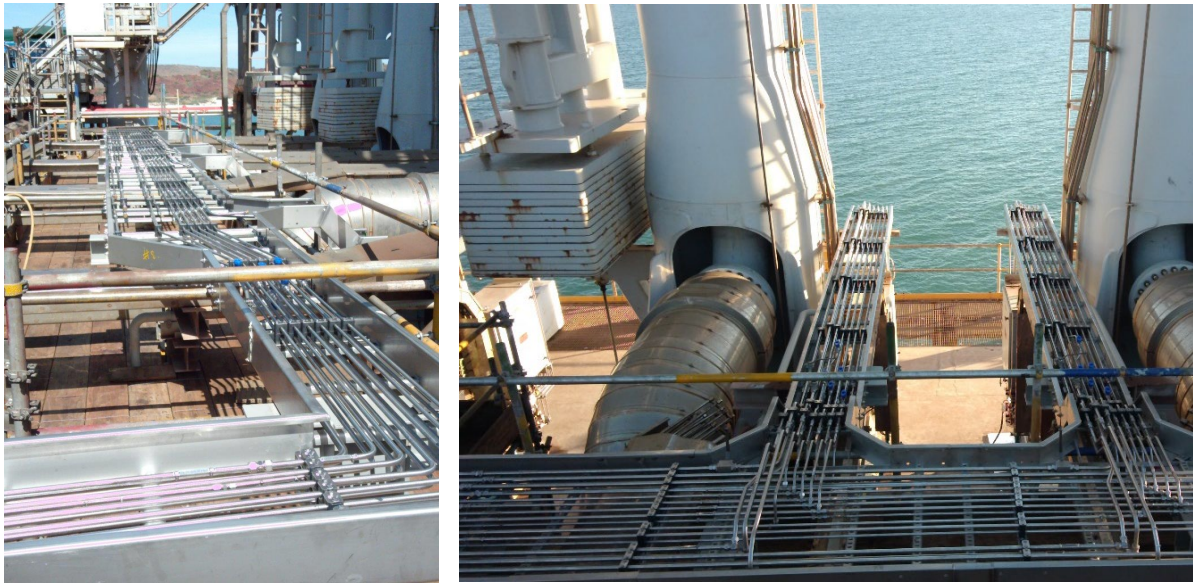
Installation, majority complete an in preparation for final flushing, then final interconnection and commissioning.
